## ROLE OF CLIMATE CHANGE AND ANTHROPOGENIC ACTIVITIES IN 2013 FLOOD DISASTER OF UTTARAKHAND

M. L. Kansal<sup>1</sup> and Sandeep Shukla<sup>2</sup>

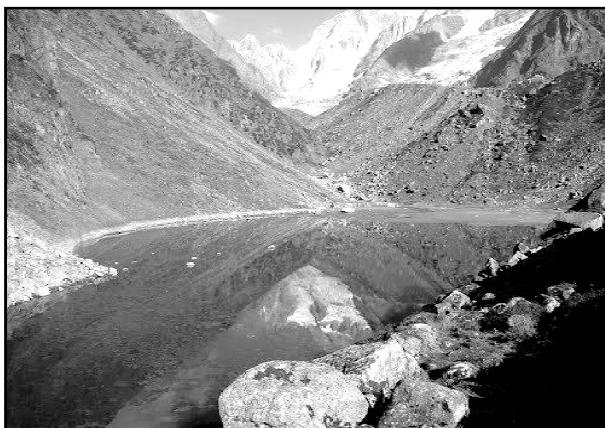
**Fig. 5: (a) Chorabari lake before flood and (b) Mechanism of GLOF (Source: Iturrizaga, 2011)**

Lake (Fig. 5a), located at the mouth of Chorabari glacier (Fig. 2b). Since the beginning of last century, number of glacier lake outburst floods (GLOF) has increased in the Himalayas. GLOFs are just one of the big threats from climate change in the Himalayas due to high emission of the GHGs. The risk of lake development is highest where the glaciers have low slope angle and low flow velocities or are stagnant. The formation of a glacier lake and its bursting mechanism is shown in Fig. 5 (b).

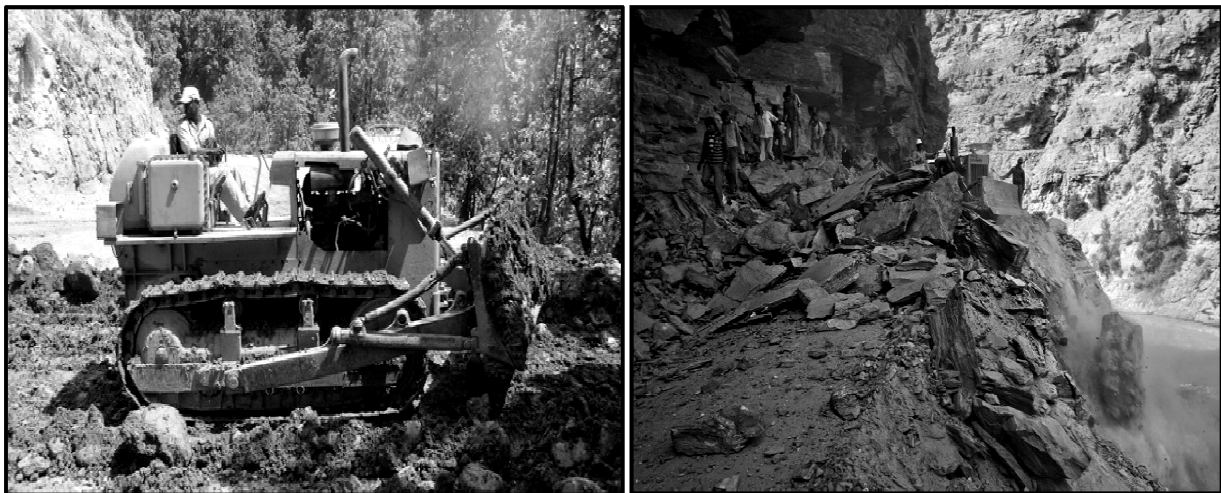
**Fig. 6: Construction and blasting on the banks of Mandakini and Alaknanda rivers**  
(Source: <http://www.downtoearth.org.in/content/uttarakhand-floods-disaster-human-induced>)

Around the Indian Himalayas new roads are constantly being built, old roads are being widened and maintained. Blasting away parts of the mountain are a part of the road-widening process. The whole process is surprisingly fast and pretty risky. Most of the construction companies, in order to clear the mountains for the development, are involved in blasting and heavy drilling of the rocks, spreading high-intensity vibrations. These are strong enough to disturb the area's tectonics and making the whole area susceptible to earthquakes of magnitude ranging from 7 to 8 and landslide. Fig. 6 shows the regular uncontrolled development on the bank of the river with heavy blasting in the state.
